SUMMARY REPORT
FOR

NAVAL SURFACE WARFARE CENTER, CARDEROCK DIVISION

LVS MOD DEMO VEHICLE
ARMOR PROTECTION KIT INSTALLATION

NATC PROJECT NO. 17859

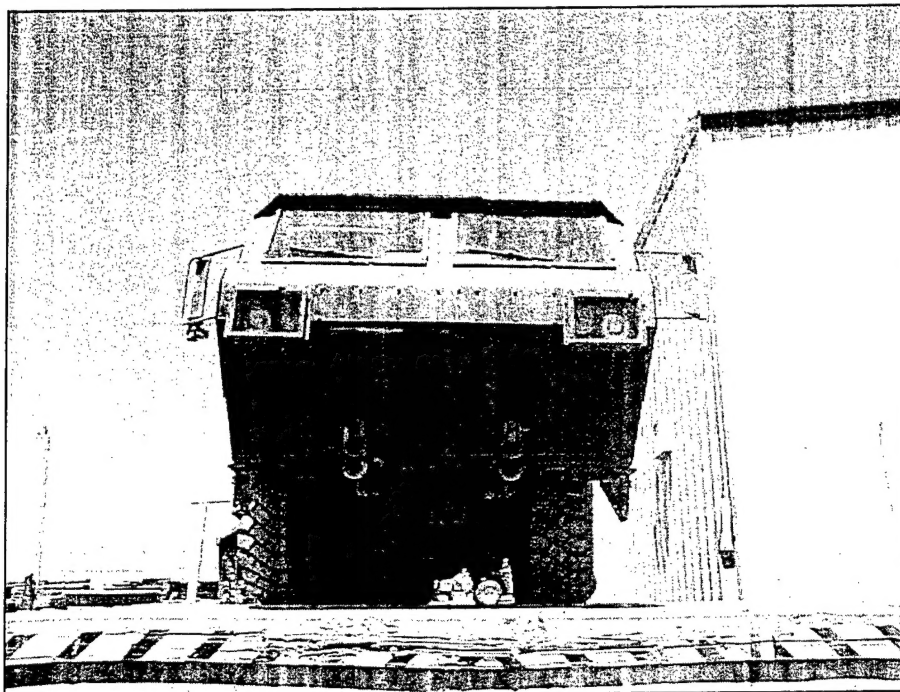
PHOTOGRAPH NO. 20238-001
LVS ARMOR PROTECTION KIT
FRONT VIEW

1. The black out lights were not connected through the armor kit (Photograph number 20238-001),
2. The upper clearance lights were not connected through the armor kit (Photograph number 20238-001),
3. Visibility is limited/restricted by the new cab enclosure (Photographs numbered 20238-030 and 031),
4. The air flow is restricted to the cab (Photographs numbered 20238-030 and 031),
5. The window locks may protrude into the occupant's head/body during an accident (Photograph number 20238-016),
6. The door handle (inside cab) is hard to reach next to the seat (Photographs numbered 20238-019 and 020),

7. There is no exit point for the occupants during an accident; i.e., the window can not be kicked out (Photographs numbered 20238-001 through 004),
8. The dead bolt door locks automatically lock during vehicle operation (Photographs numbered 20238-017 and 018),

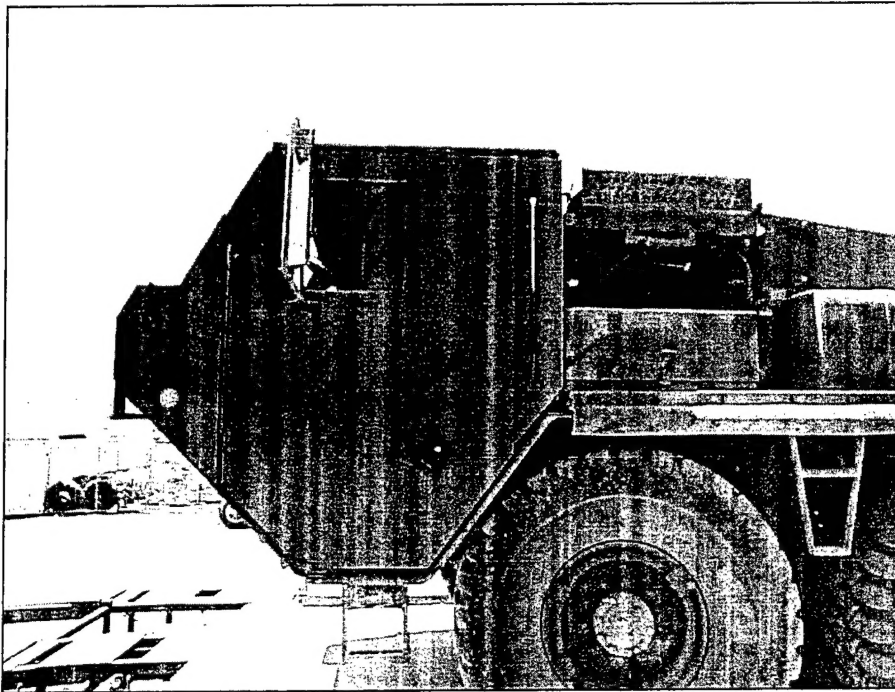
PHOTOGRAPH NO. 20238-003
LVS ARMOR PROTECTION KIT
DRIVER SIDE VIEW

12. The underbody plate will act as a mud trap and corrosion issues are probable (Photographs numbered 20238-003 and 029),
13. The doors are too heavy for the hinges; occupants get trapped inside the vehicle due to hinges getting off track (Photograph number 20238-010),

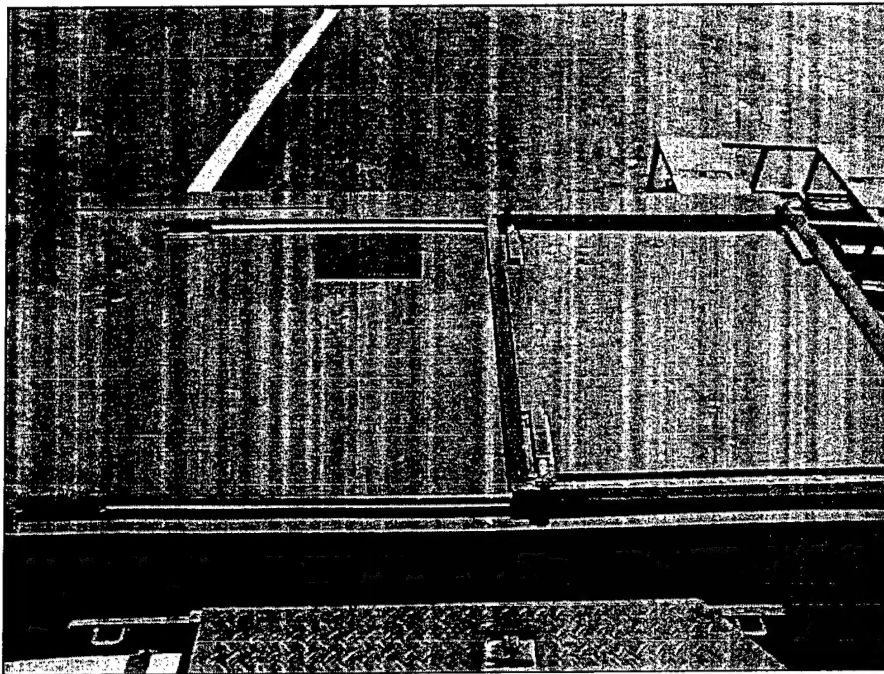
PHOTOGRAPH NO. 20238-004
LVS ARMOR PROTECTION KIT
TOP CENTER VIEW

9. The bolts in the roof are protruding into the cab area creating a probability of head injury (Photographs numbered 20238-013 and 015),
10. The roof hatch is hard to lift and does not seem to slide; no 95th percentile provisions (Photographs numbered 20238-004 and 005),

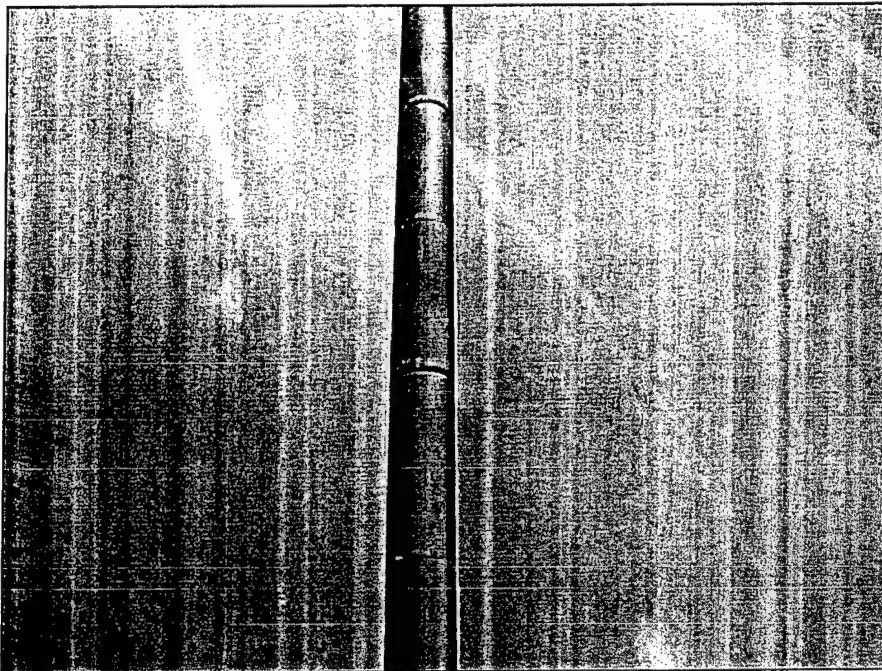
PHOTOGRAPH NO. 20238-010
LVS ARMOR PROTECTION KIT
DRIVER SIDE DOOR HINGE

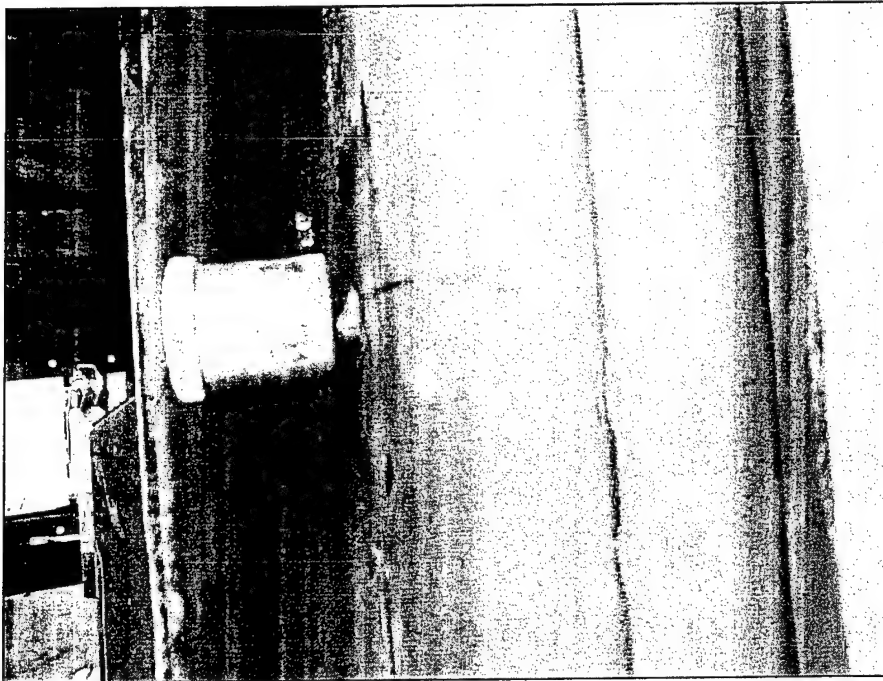
16. The driver and passenger side upper door pins are loose (Photograph number 20238-011),
17. There is a gap in the armor plate on both sides; only one bolt holds the armor kit on, the other bolt is only through the sheet metal (Photograph number 20238-012),

PHOTOGRAPH NO. 20238-011
LVS ARMOR PROTECTION KIT
UPPER DOOR PIN LOOSE – CONTACT MARKS FROM DOOR

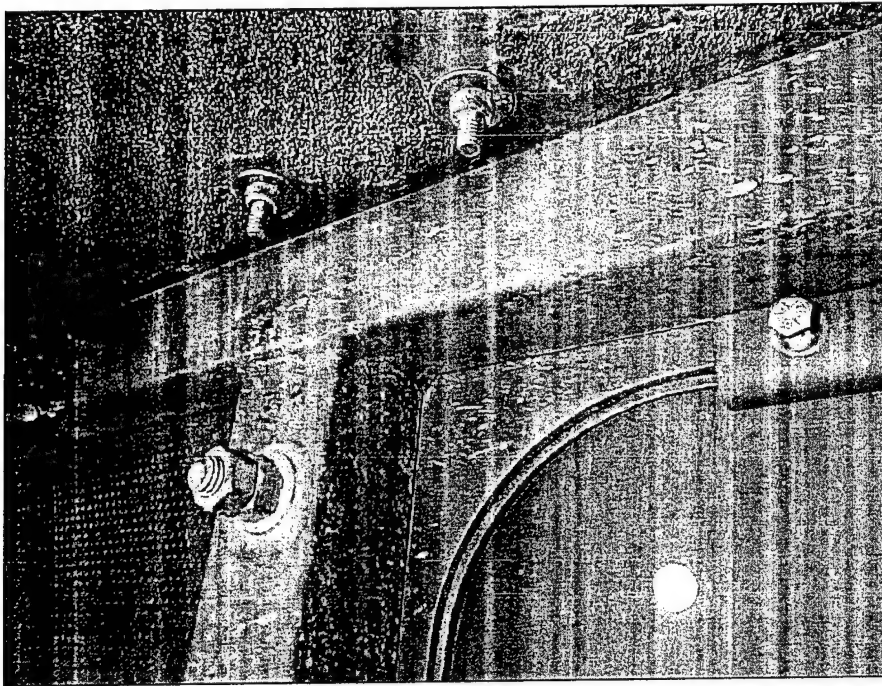
11. The entire cab has protruding bolts into the cab space creating a probability of head injuries (Photographs numbered 20238-013, 014, 015, 023, 024, 025 and 027),

PHOTOGRAPH NO. 20238-013
LVS ARMOR PROTECTION KIT
PROTRUDING BOLTS – DRIVER'S SIDE ROOF

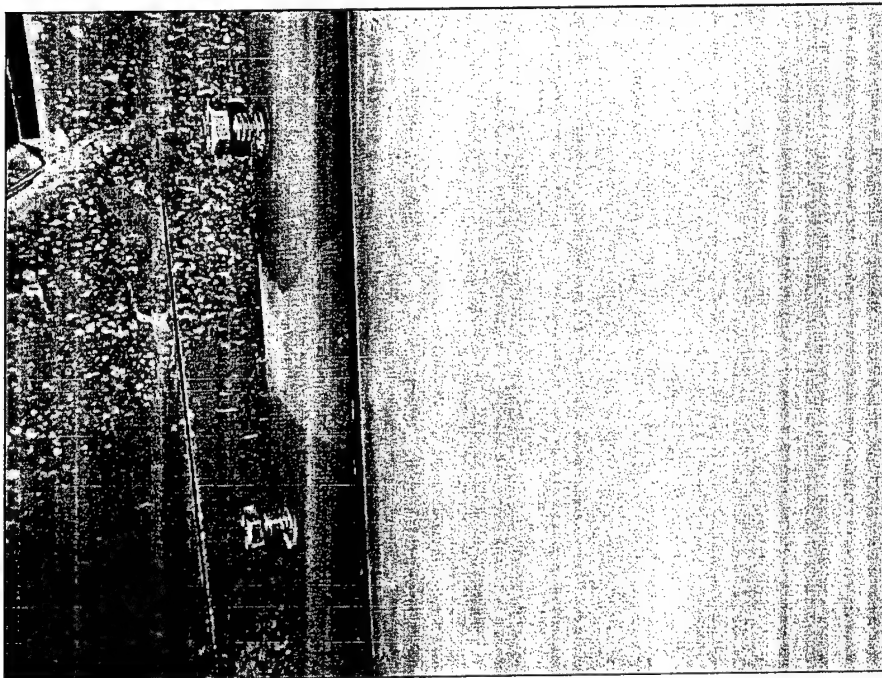
PHOTOGRAPH NO. 20238-014
LVS ARMOR PROTECTION KIT
PROTRUDING BOLTS BEHIND DRIVER'S SEAT

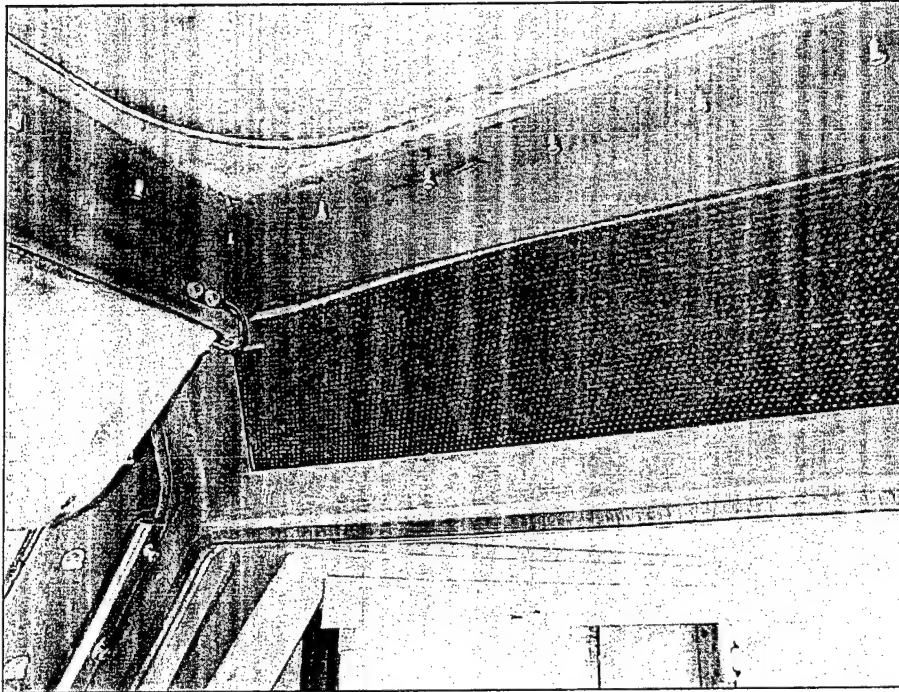
PHOTOGRAPH NO. 20238-015
LVS ARMOR PROTECTION KIT
PROTRUDING BOLTS – PASSENGER'S SIDE HATCH

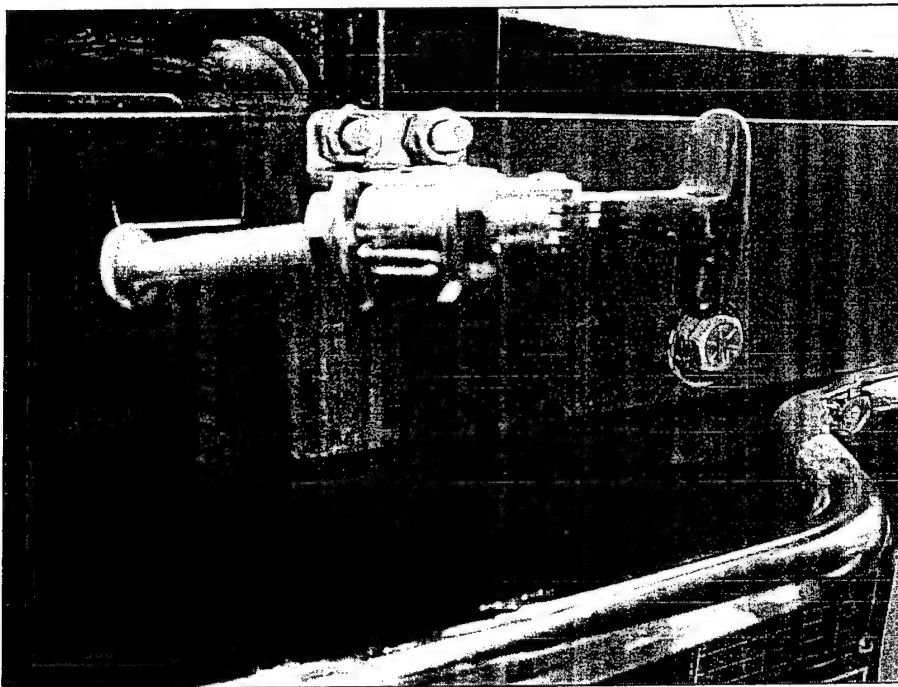
PHOTOGRAPH NO. 20238-016
LVS ARMOR PROTECTION KIT
WINDOW LOCKS NOT TIGHT/OPERATIONAL

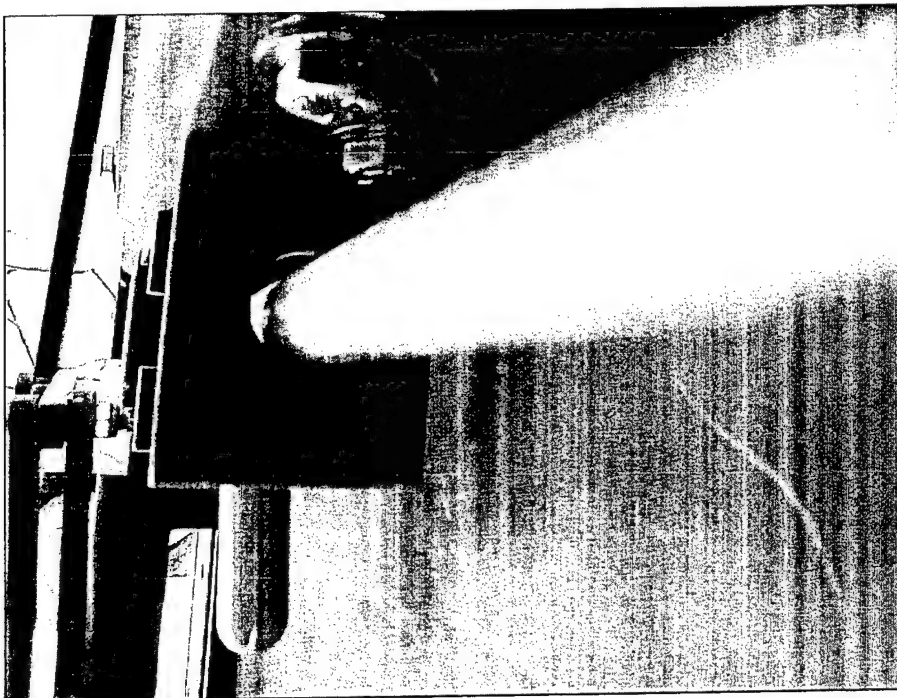
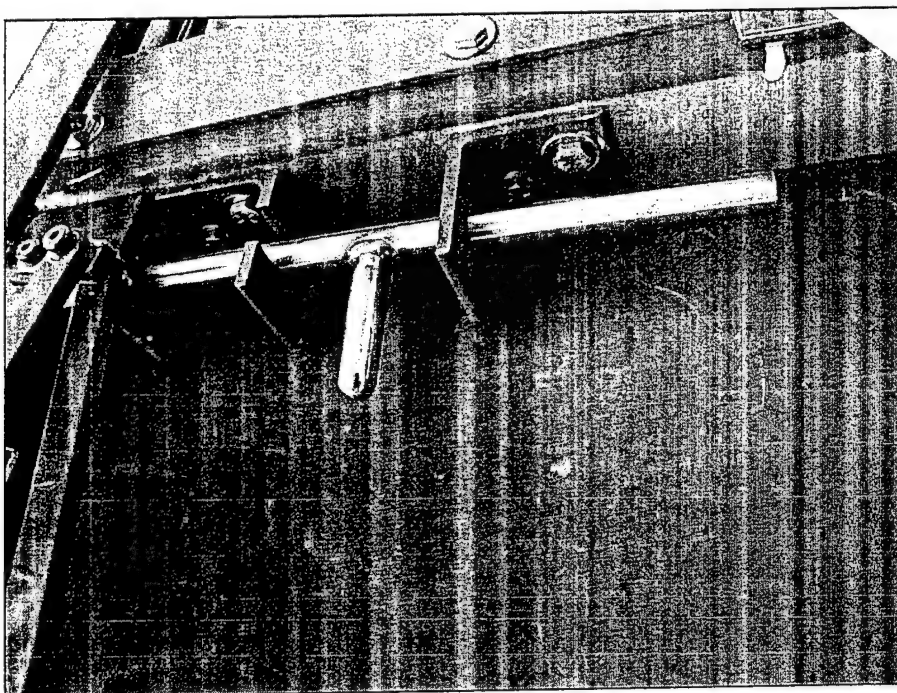
PHOTOGRAPH NO. 20238-017
LVS ARMOR PROTECTION KIT
DEAD BOLT DOOR LOCK NOT TIGHT - RATTLES

PHOTOGRAPH NO. 20238-018
LVS ARMOR PROTECTION KIT
DEAD BOLT DOOR LOCK NOT TIGHT - RATTLES

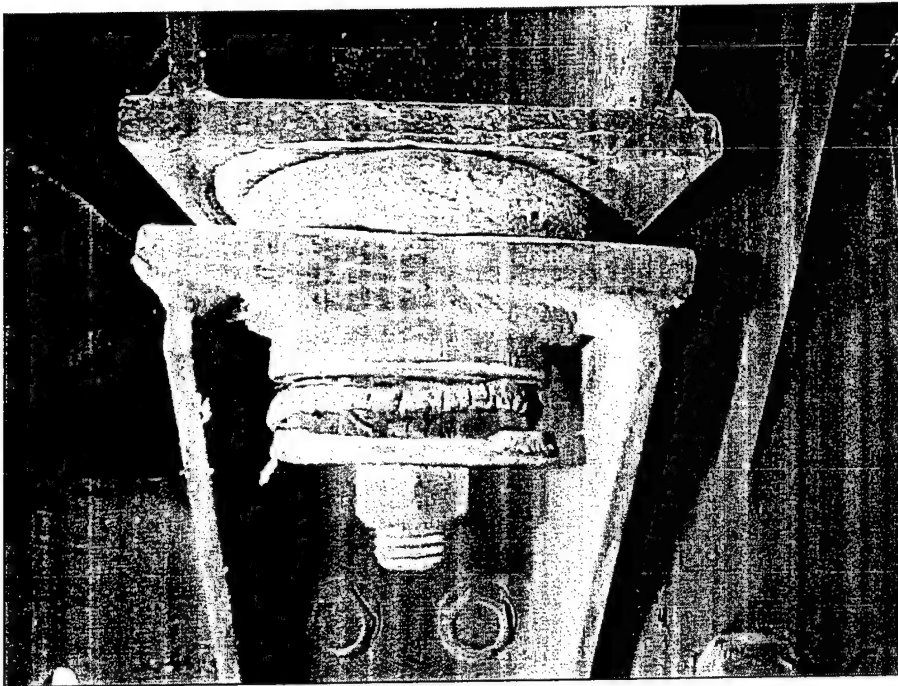
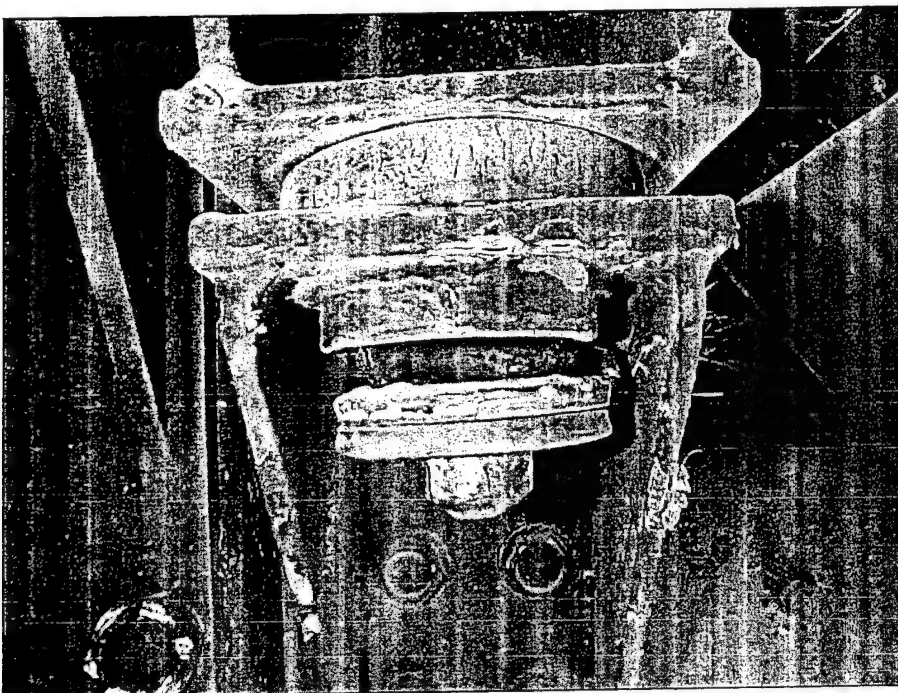
PHOTOGRAPH NO. 20238-021
LVS ARMOR PROTECTION KIT
DRIVER SIDE CAB MOUNTS

19. There is no access to clean the headlights; space will serve as a mud trap (Photograph number 20238-028), and
20. The cab mounts are deteriorating due to the additional weight (Photographs numbered 20238-021 and 022).

1. Address the twenty-one items identified should further development be merited.
2. Perform accelerated fatigue testing of the vehicle.
3. Redesign the cab mounts to consist of a stiffer material.

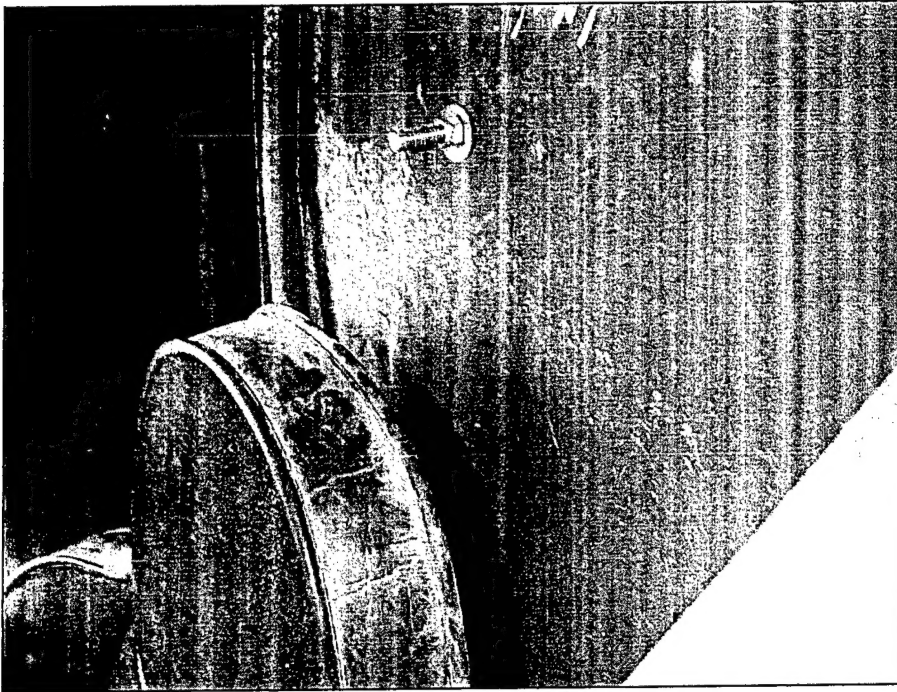
PHOTOGRAPH NO. 20238-023
LVS ARMOR PROTECTION KIT
PROTRUDING BOLTS PASSENGER SIDE

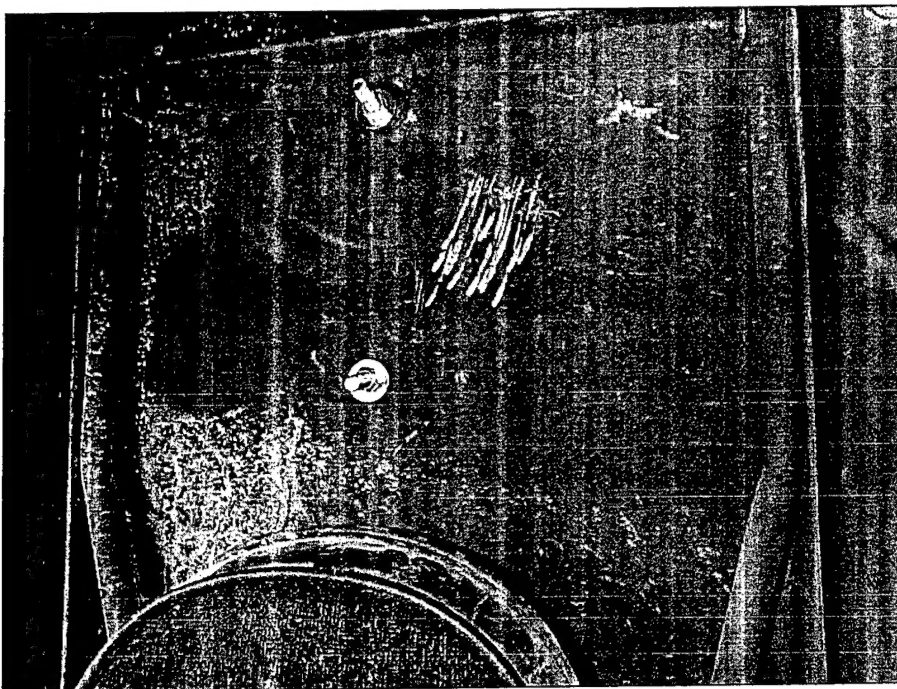
14. The armor kit is bolted through the gunner's platform; platform not operational (Photographs numbered 20238-024 and 027),
15. The cab structure tube is crushed due to no support for bolts (Photograph number 20238-025),

PHOTOGRAPH NO. 20238-024
LVS ARMOR PROTECTION KIT
PROTRUDING BOLTS PASSENGER SIDE

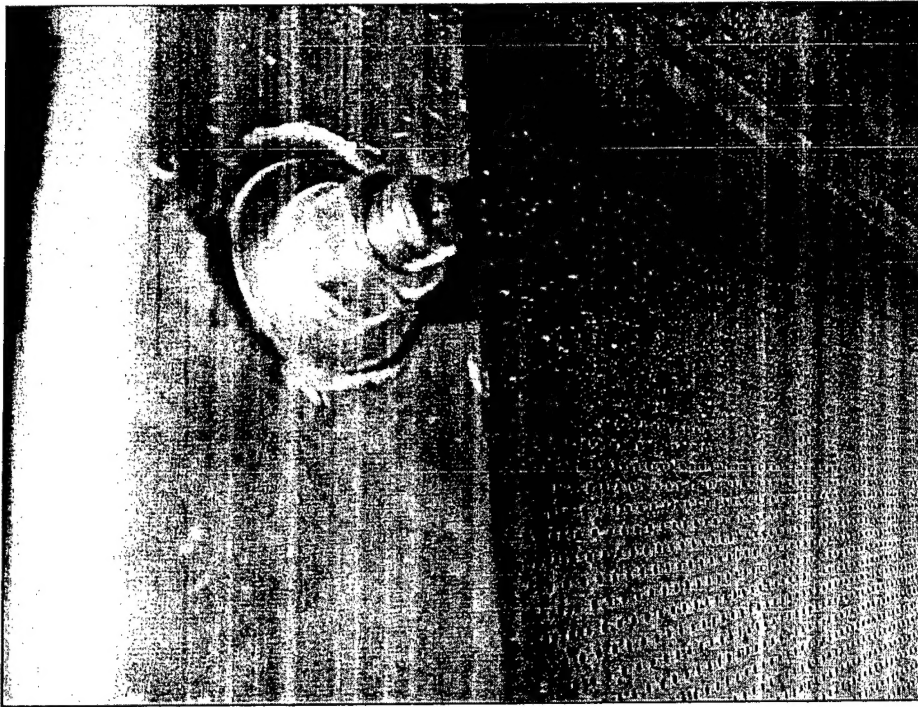
PHOTOGRAPH NO. 20238-025
LVS ARMOR PROTECTION KIT
CRUSHED CAB STRUCTURE TUBE

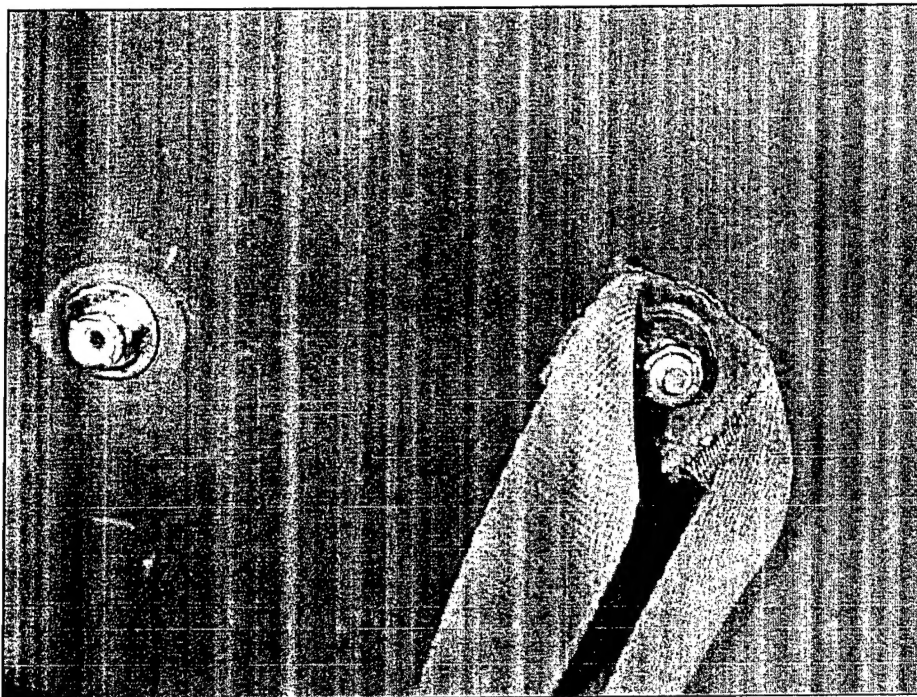
18. There is no thread engagement on the nylon bolts inside the cab in the front and gunner's hatch areas (Photograph number 20238-026),

PHOTOGRAPH NO. 20238-026
LVS ARMOR PROTECTION KIT
NYLON BOLT NOT ENGAGED

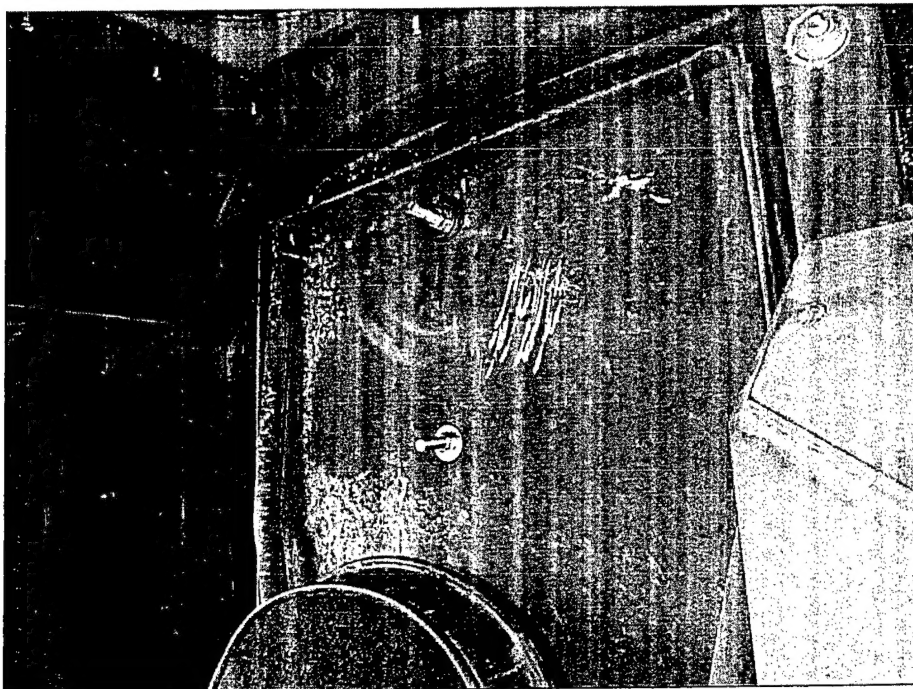
PHOTOGRAPH NO. 20238-027
LVS ARMOR PROTECTION KIT
GUNNER'S PLATFORM BOLTED TO ARMOR

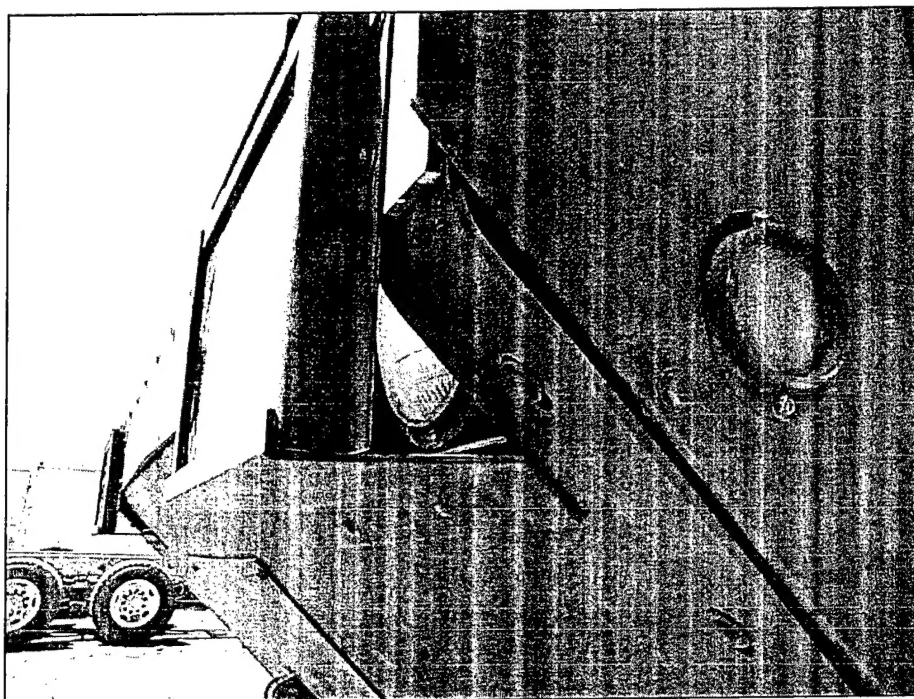
PHOTOGRAPH NO. 20238-028
LVS ARMOR PROTECTION KIT
HEADLIGHT ACCESS ELIMINATED/ MUD TRAP AREA

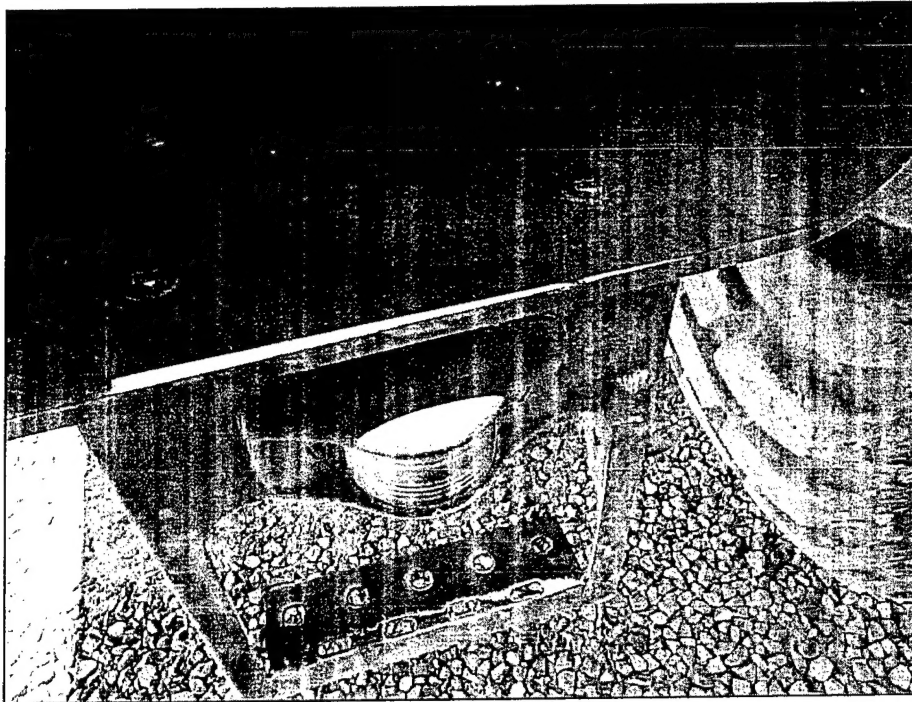
PHOTOGRAPH NO. 20238-029
LVS ARMOR PROTECTION KIT
NO TRACTION ON ARMOR PLATE STEP
